## Summary of Report: PA-09-190

## Al Hadi Permanent Police Station

SUBJECT: Report on the Al Hadi Permanent Police Station, Basrah, Iraq (SIGIR Report Number PA-09-190)

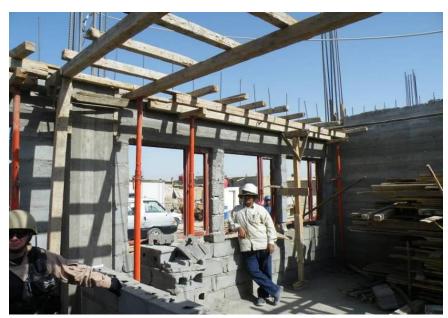
Site Photo 7. Reinforced concrete beam formwork

During the site inspection, the contractor was constructing the police station structure. The structure for the police station consists of a two-story reinforced concrete frame with reinforced concrete masonry infill. At the time of the site assessment, the contractor completed construction of the concrete columns for the first floor and had partially constructed the reinforced concrete masonry infill. While the masonry work was progressing with the walls, the contractor was constructing formwork to place the reinforced concrete beams for the second story (Site Photo 7).

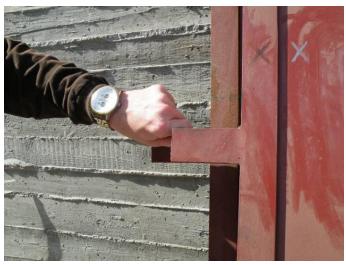
Site Photo 11. Embedment tab

During the construction of the reinforced CMU exterior walls, the contractor installed the steel window and door frames. The steel frames consist of welded steel sections and steel embedment tabs (Site Photo 11) securing the windows and doors to the walls. The embedment tabs are steel angle sections approximately 10 cm in length. The tabs are placed in the mortar joints of the CMU and held in place with the mortar. To plumb the windows, the opening in the CMU was constructed larger than required leaving a gap which can be used for leveling (Site Photo 12). Due to this gap, the actual length of embedment in some cases can be as little as 5 cm, so the strength of the window attachment is less than the strength of the surrounding concrete masonry wall.

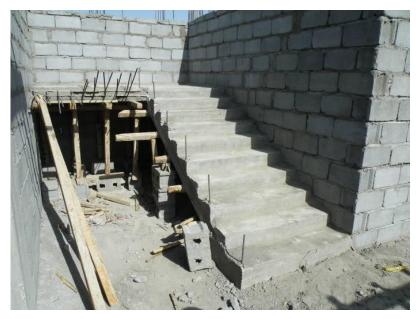
Site Photo 13. Reinforced concrete stairs

At the time of the site assessment, the contractor constructed the first half-flight of stairs (Site Photo 13). The stairs are constructed of reinforced concrete. Dowels were present at the landing to tie the reinforcing material for the next flight. The construction appeared adequate. The risers were a uniform height and the treads were level and even.
